Manhole Inspection Summary

Manhole # S57G__014MH

Insp Date: **7/29/08 10:14 AM**

Location Address: **240 s janey st**

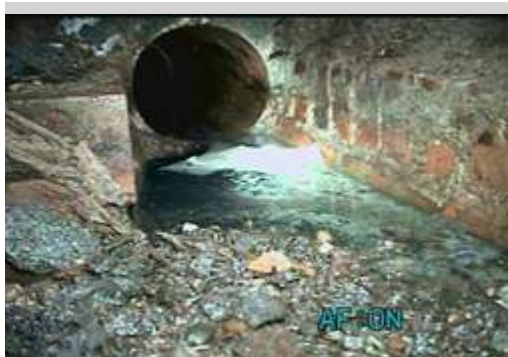
Defect 4

Condition: ☐ Sound ☐ Cracked ☐ Root Intrusion ☐ Deteriorated ☐ Leaks ☒ **Debris**

channel debris

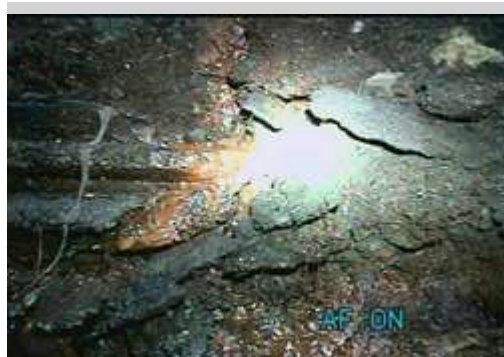
Defect 3

Condition: ☐ Sound ☐ Cracked ☐ Root Intrusion ☐ Deteriorated ☐ Leaks ☒ **Debris**

bench debris

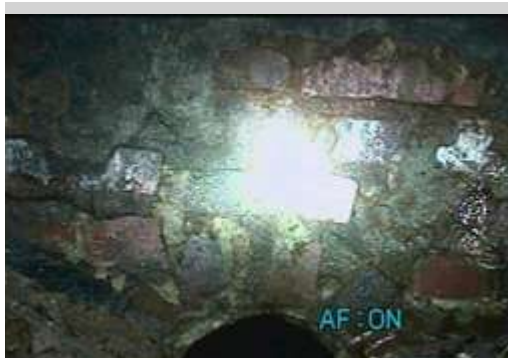
Defect 2

Infiltration: ☐ None ☐ Joint ☐ Cracks ☐ Mortar ☐ Roots ☒ **Wall**

barrel infiltration

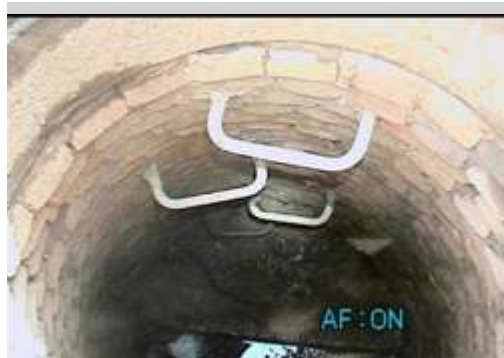
Defect 1

Steps Count: **4** Missing: **0** ☒ **Corroded**

corroded steps
